REPORT

June 2020

CITY OF
Fitchburg
MASSACHUSETTS

Preliminary Plan of Action for the North
Nashua River Flood Damage Reduction
System

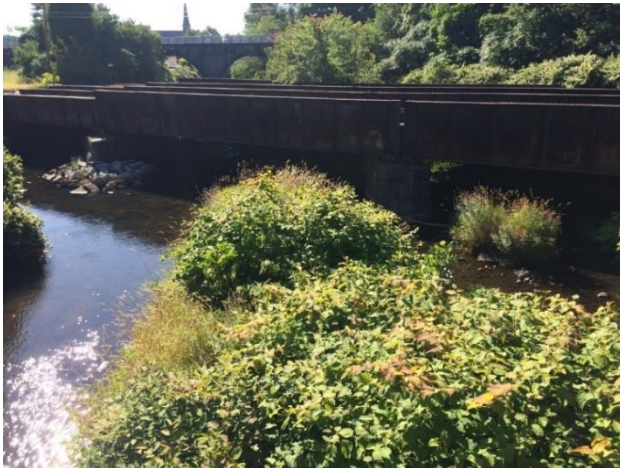
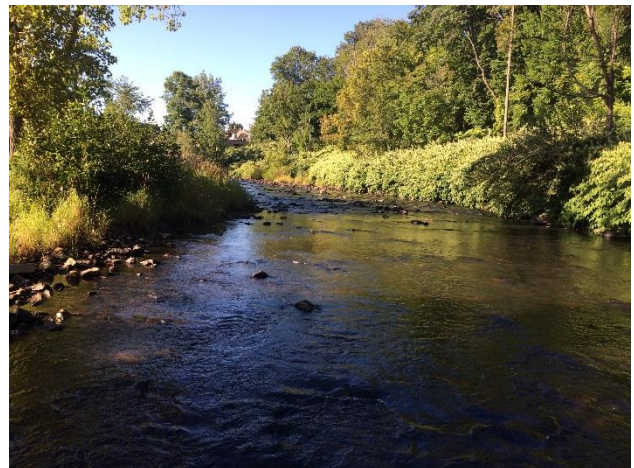
Dense vegetation, including brush and trees, were present along the slopes and in the channel for much of the FDR System. The vegetation obscured observation in several locations. Significant vegetation, enabled, in part, by significant shoaling, was present in many locations within the North Nashua River reach protected by the FDR System.

Significant vegetation consisting of large, dense brush and trees is present along the channel slopes for the entire FDR System. The heavy vegetation prevents a thorough inspection of the FDR System and may obscure additional deficiencies. Root systems from dense vegetation can also damage structures by causing movement and cracking and displace slope protection like riprap. Vegetation within the channel will also reduce the hydraulic capacity of the channel. Vegetation should be removed and maintained. After removal, the FDR System should be re-inspected for additional deficiencies. Once vegetation has been removed, additional deficiencies may be noted, which may result in additional projects, alter cost estimates of existing projects, or alter the prioritization of projects in this report.

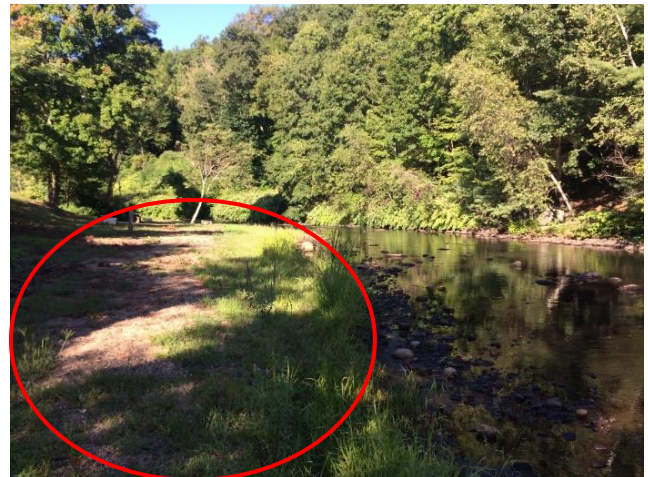
Areas with unprotected slopes were also observed, such as the right bank between River Street and Sheldon Street. Observations of unprotected slopes were limited by dense vegetation. Unprotected slopes are susceptible to erosion, which can deposit sediment into the channel.

Armoring of slopes with riprap reduces the effects of erosion on slope stability. Riprap can also reduce vegetation growth on slopes. Much of the earthen slopes were overgrown with vegetation, obscuring observation of the presence of riprap.

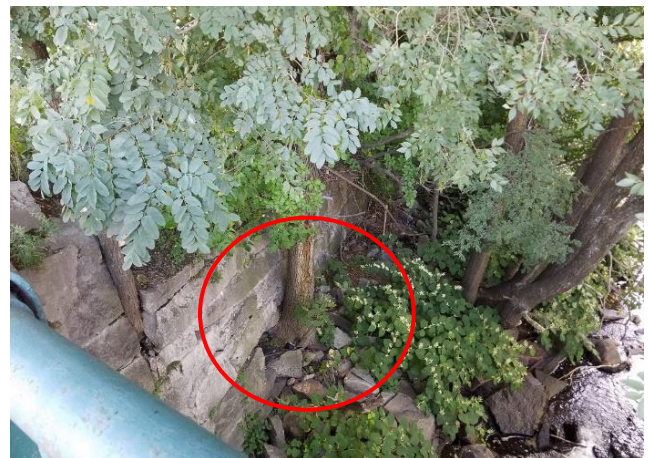
Trees were present within a retaining wall on the left downstream bank near the River Street Bridge at Crocker Field. The trees appear to have displaced stone blocks within the retaining in this location. Dense vegetation prevented observations of similar occurrences elsewhere in the FDR system, but they are likely.

A specific location where trees have caused displacement in the FDR System already is at the River Street Bridge near Crocker Field. Trees have displaced the stone blocks of the retaining wall at the left bank. The trees should be removed from within 15 feet of the wall and the wall should be repaired, as necessary.

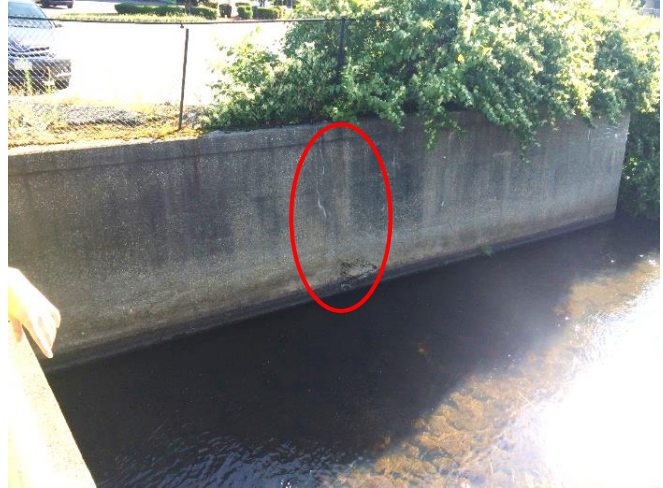
Many of the floodwalls along the FDR System were unobservable due to vegetation. However, of the observable floodwalls, several were observed with significant deterioration including spalling and cracking.

The floodwalls are generally made of concrete or stone masonry. The visible portions of the walls have noticeable deficiencies such as spalling, cracking and efflorescence. Much of the floodwalls could not be observed due to vegetation. Based on the condition of the visible portions of floodwalls, we assume that all flood walls will need minor repairs. This estimate may change after the floodwalls are exposed by vegetation removal. In addition, more significant floodwall repairs may be exposed, which may increase the prioritization of this project.

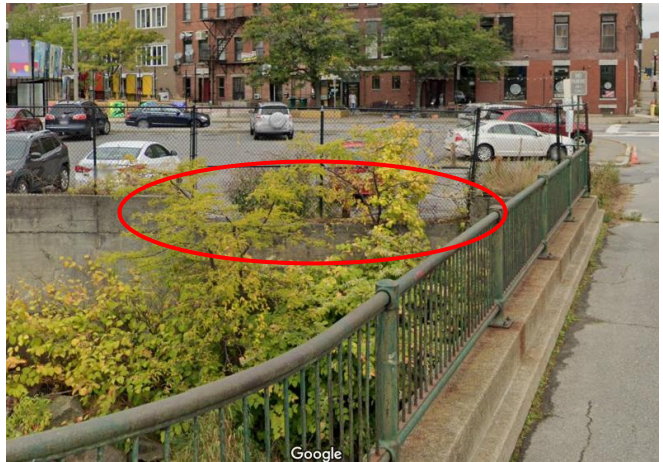
The concrete floodwalls along the left side of the river between Putnam Street and Commercial Street had missing concrete within the approximate top one foot of the walls in at least three locations. Each missing section was approximately 10 feet long. These reduce the flood level against which the FDR System can effectively function in this area.

The USACE inspection report notes gaps in the floodwall between Putnam Street and Commercial Street near Riverfront Park. Based on visual observations, there appear to be four 10-foot wide areas where the approximate top foot of the floodwall has been removed. These sections should be repaired to match the top of the adjacent wall sections. *Figure 7* identifies the four locations.

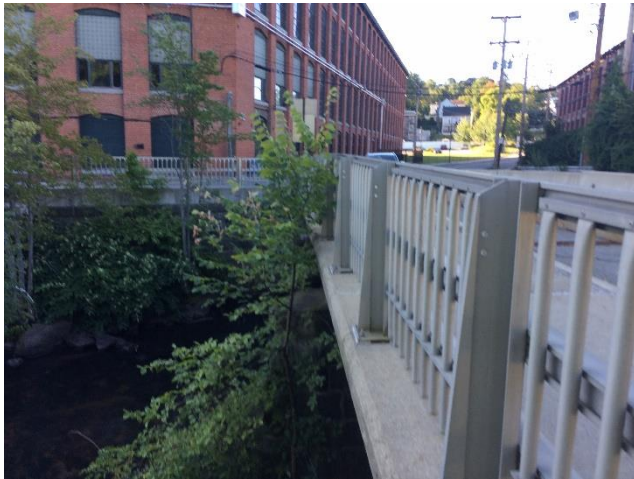
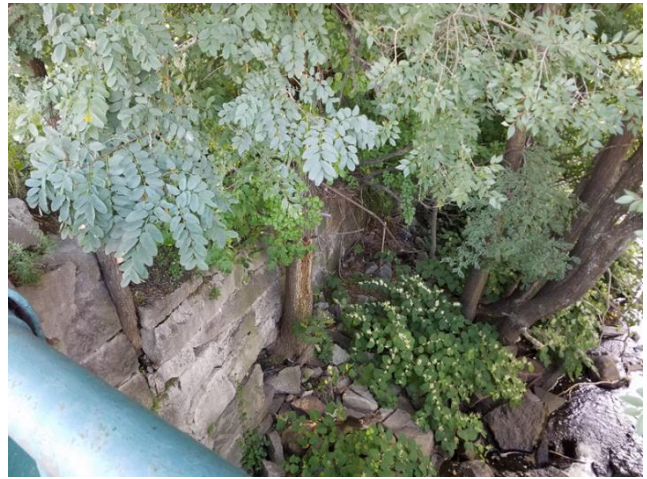
Tree roots that are adjacent to a floodwall can cause it to become displaced and move towards the channel, reducing the hydraulic capacity of the channel and eventually causing a wall failure. Trees should be removed from within 15 feet of floodwalls to reduce the chances of a wall failure. Refer to *Figure 2* for the approximate areas of vegetation maintenance.

Based on site visits, photographs, and aerial imagery, we estimate that approximately 170,950 square feet of area around the floodwalls will need to be cleared. This work could cost approximately \$150,000. For permitting, we assume that no work will be done within the channel. A Notice of Intent will likely be required. The costs associated with preparing and submitting this permit would be in the \$8,000 - \$13,000 range.

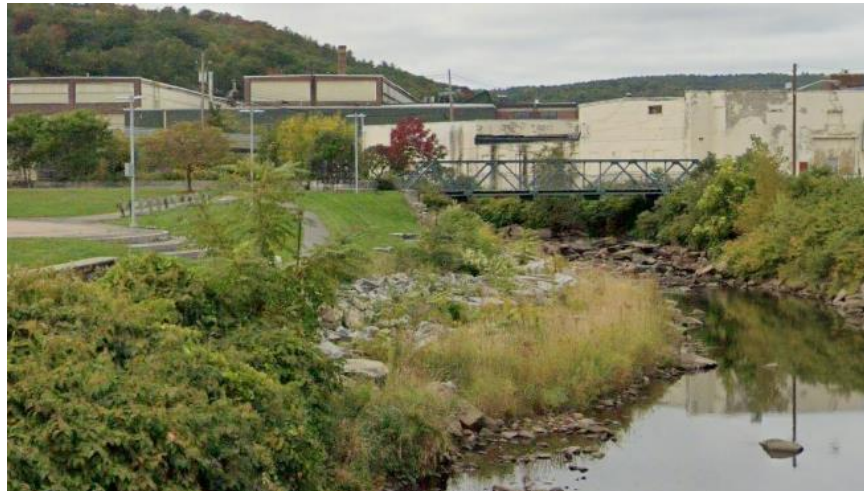
The USACE noted that, in several locations, riprap has been displaced and should be restored. Riprap protects earthen slopes from erosion. It can also limit the presence of vegetation. Displaced riprap leaves the slope exposed. **Figure 3** shows the locations of areas where riprap is present but will likely need to be supplemented. It should be noted that once the vegetation has been removed from the slopes, the estimated quantity needed may change.

There is approximately 12,290 feet of earthen slope along the FDR System. We estimate that approximately 7,850 feet of that length has existing riprap slope protection. We are assuming that all existing riprap sections will need to be supplemented with additional riprap. Based on these assumptions, the estimated cost is approximately \$350,000. The riprap will likely be placed below the normal waterline. The following environmental permits may be required: a Notice of Intent, a Massachusetts Environmental Policy Act (MEPA) Environmental Notification Form (ENF), a Massachusetts Department of Environmental Protection (MassDEP) Water Quality Certificate (WQC), a MassDEP Chapter 91, and a United States Army Corps of Engineers (Corps) Pre-Construction Notification (PNF). Costs associated with preparing and submitting these permits would be in the \$35,000 - \$45,000 range.

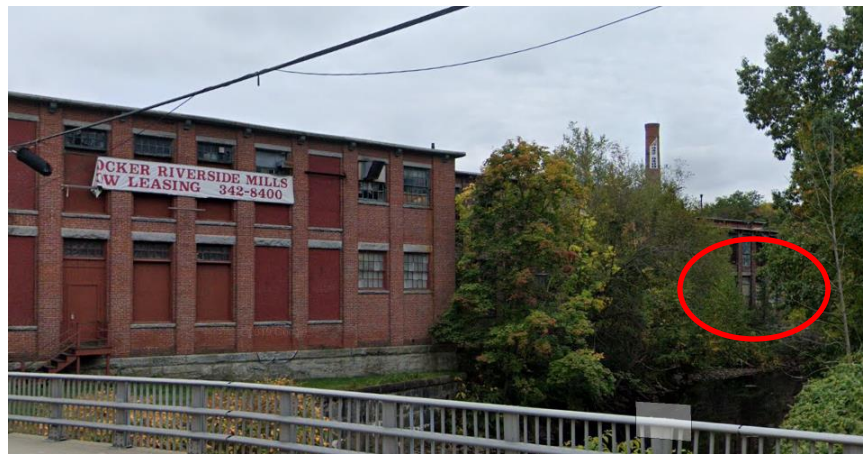
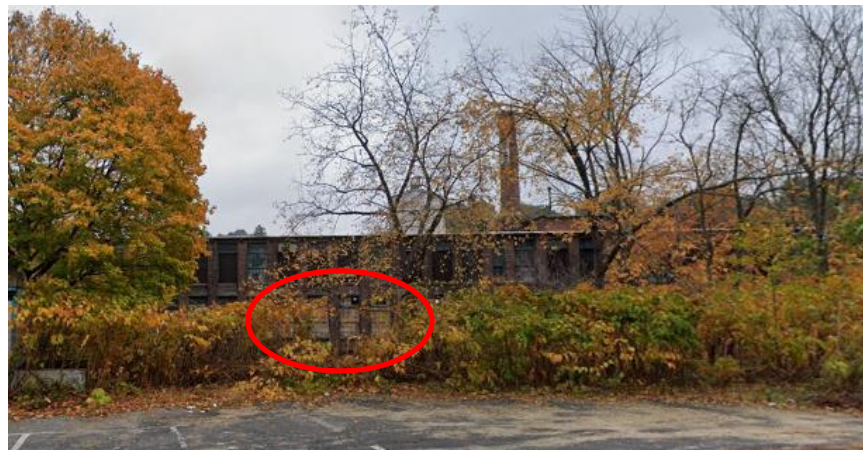
The Crocker Riverside Mills abuts the North Nashua River. Based on our flood risk and impact analyses, the reach of the FDR System upstream of Oak Hill Road may be vulnerable to overtopping with flood levels reaching up to El. 499. The windows on the river side of the first floor of the building should be floodproofed to prevent the interior of the building from flooding. We estimate that there are approximately 60 windows. Refer to *Figure 8* for the project location.

One way to floodproof windows is to brick them. Brick costs approximately \$50 per square foot. We estimate that each window is approximately 30 square feet based on field observations. The total cost for this project is, therefore, approximately \$100,000. Measurements should be taken in the field for a more accurate estimate. Assuming that work will occur within 200 feet from the channel or in the 100-foot flood zone, a Notice of Intent will likely be required. Costs associated with preparing and submitting this permit would be in the \$8,000 - \$13,000 range.

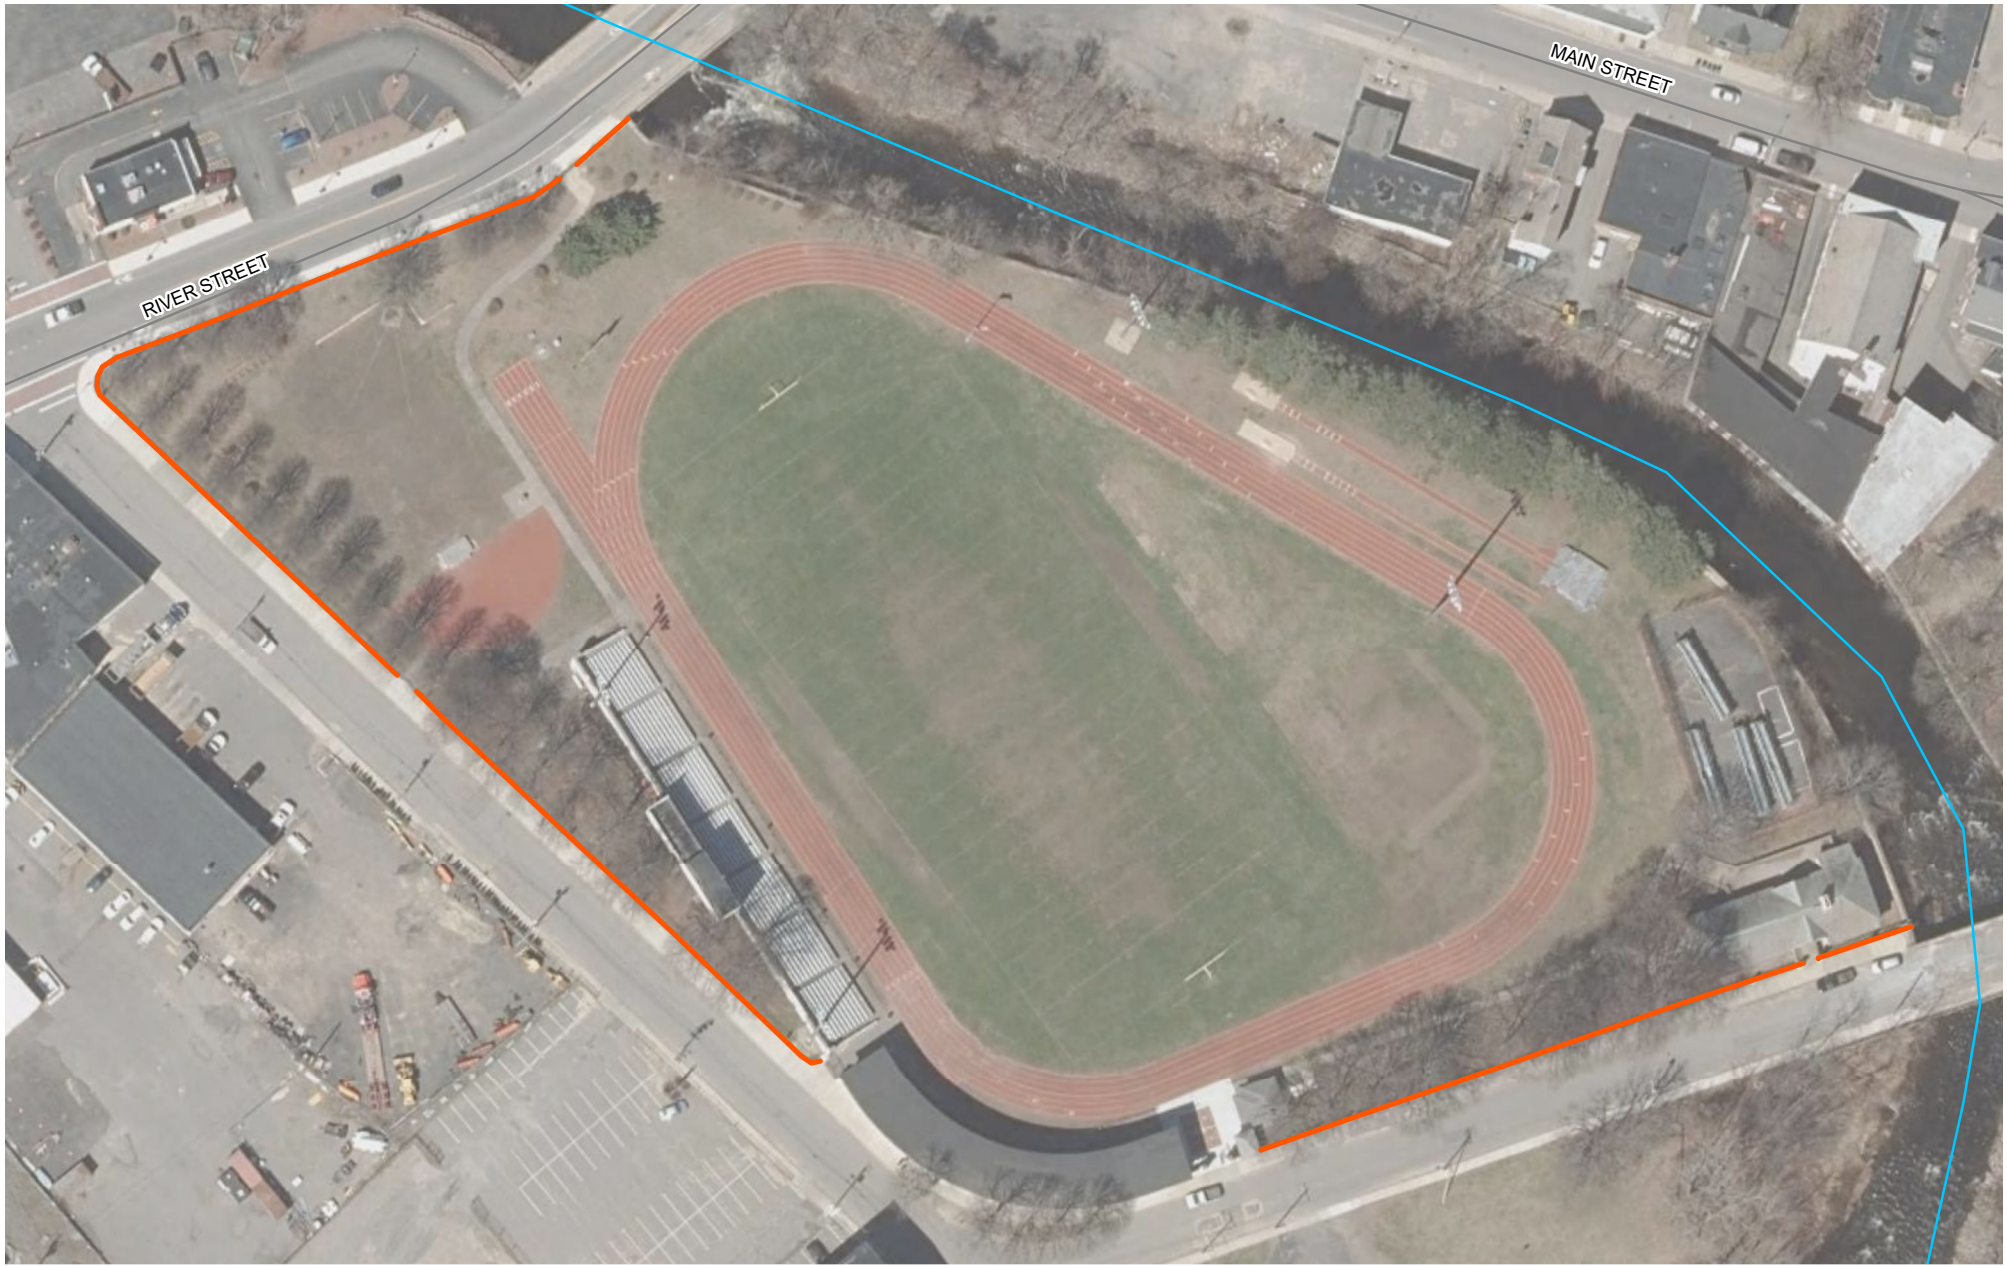
FIGURE 10
CITY OF FITCHBURG
CROCKER FIELD FLOOD STORAGE

Based on our flood risk and impact analyses, the reach of the FDR System near Crocker Field may be vulnerable to overtopping with flood levels reaching up to El. 464. During a flood, Crocker Field will act as a conduit for overflows to reach adjacent low-lying areas. To reduce the impacts of flooding on this area, Crocker Field can be used as intentional flood storage during a storm event. Currently, an approximately 1,125-foot-long iron fence with four 8-foot wide gates surrounds Crocker Field on the three non-river sides. The outline of the existing fence is shown in *Figure 10*. The fence can be replaced with an approximately 2.5-foot tall concrete or stone masonry wall that will act as a barrier between the surrounding streets and Crocker Field. Four 3-foot-tall bladder dams can be built into the ground at the gate locations to prevent flow from passing through. These bladder dams would be embedded in the concrete ground surface normally but could be quickly inflated during large flood events.

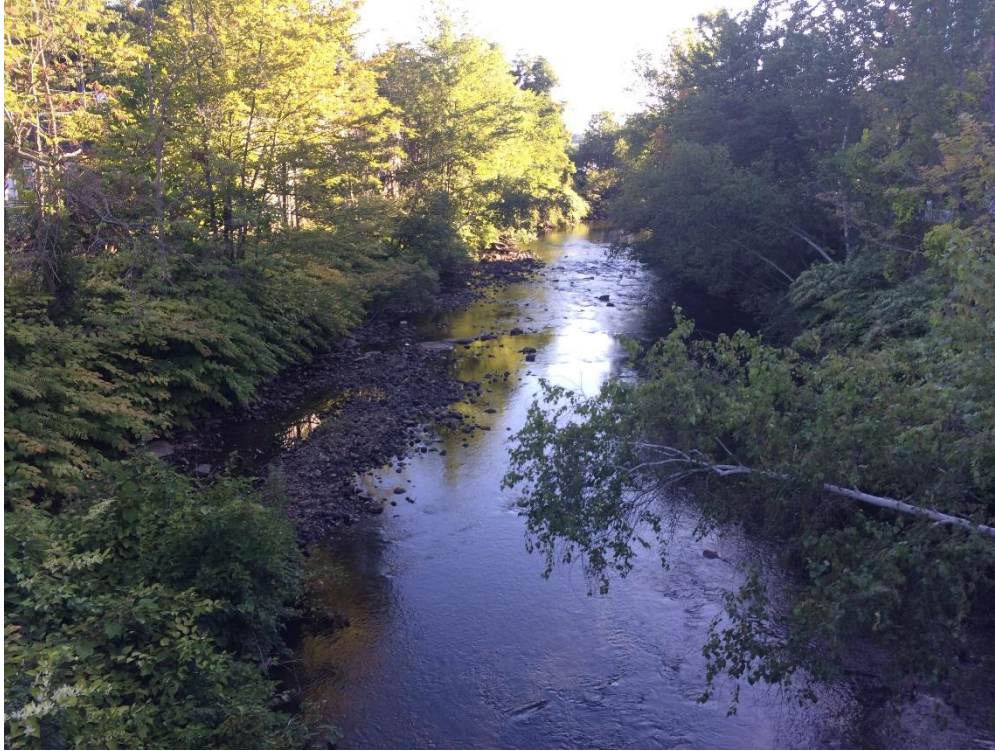
Photograph 1: Vegetation and shoaling downstream of Oak Hill Road.

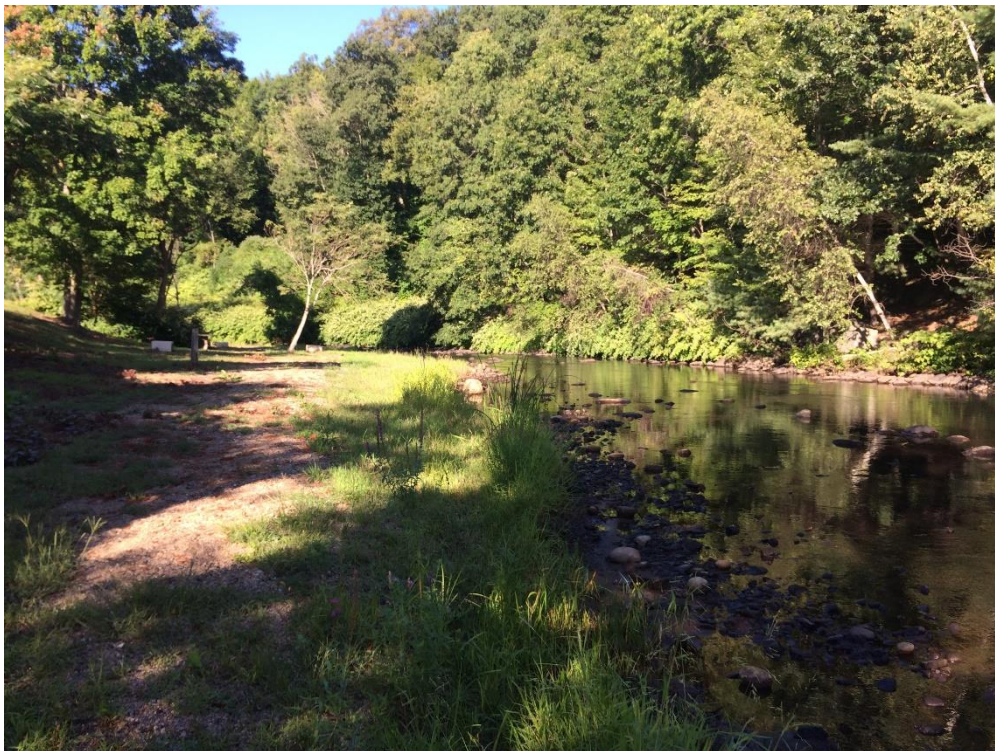
Photograph 2: Vegetation and unprotected slope downstream of River Street and upstream of Sheldon Street.

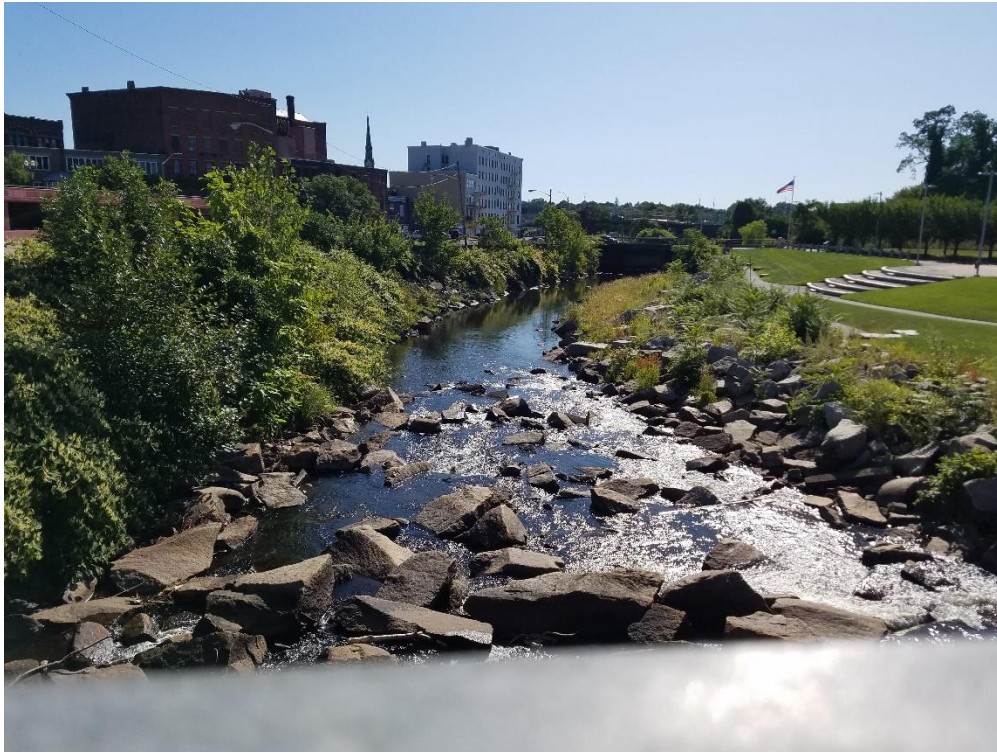
Photograph 3: Vegetation downstream of Putnam Street and upstream of Commercial Street.

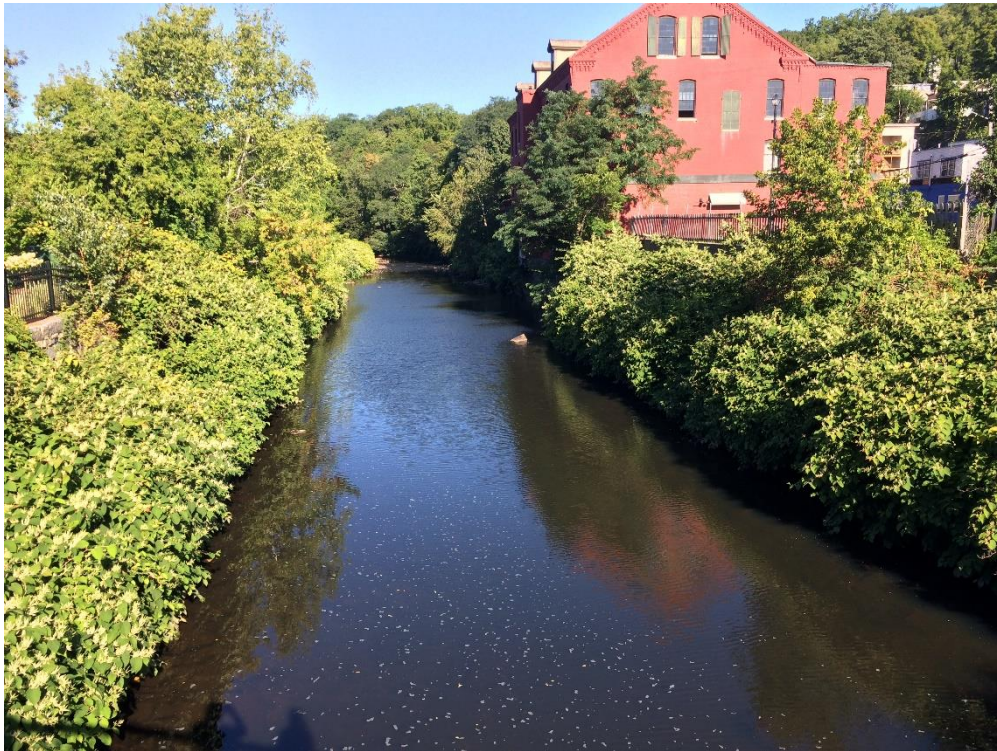
Photograph 4: Vegetation upstream of River Street.

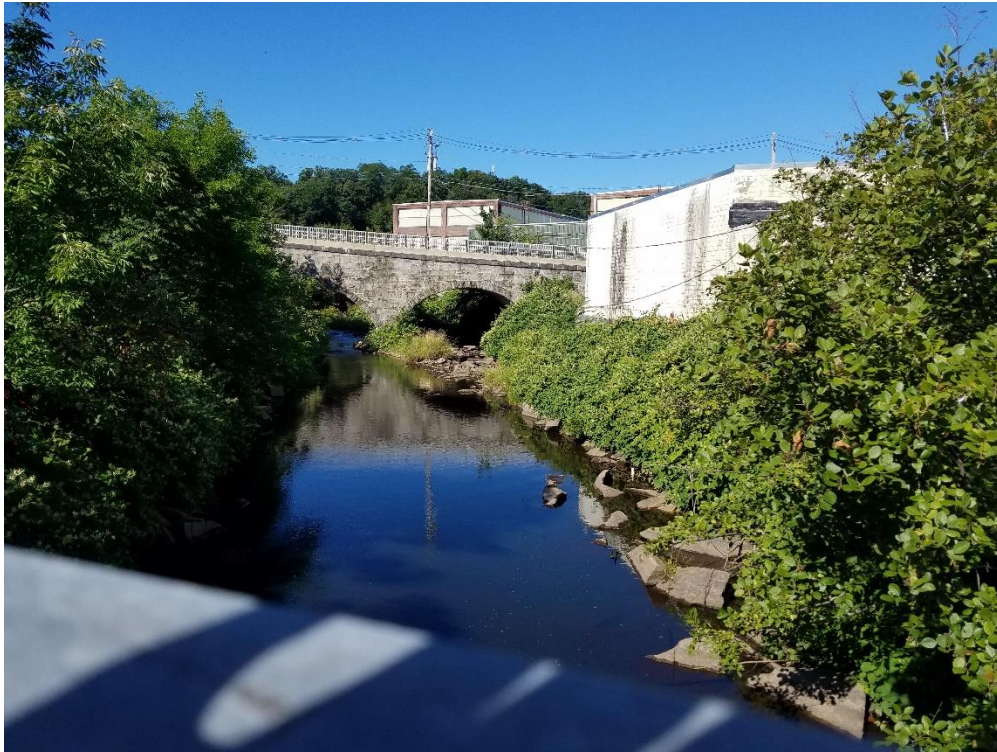
Photograph 5: Vegetation and shoaling downstream of Putnam Street.

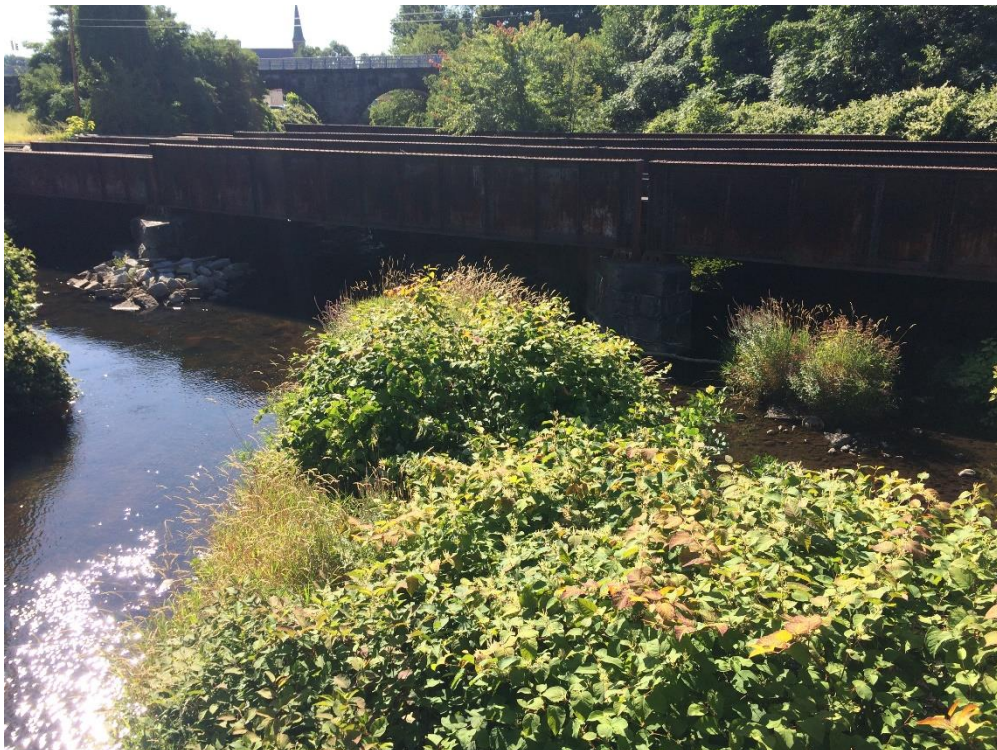
Photograph 6: Vegetation and shoaling downstream of Commercial Street.

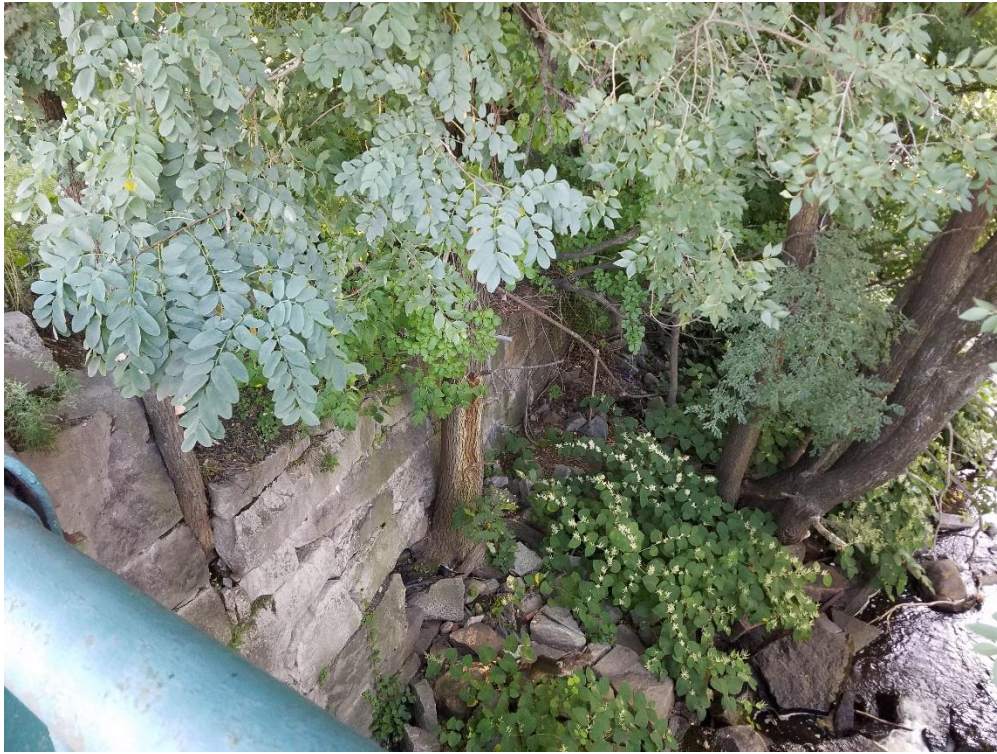
Photograph 7: Vegetation and displaced stone blocks downstream of River Street.

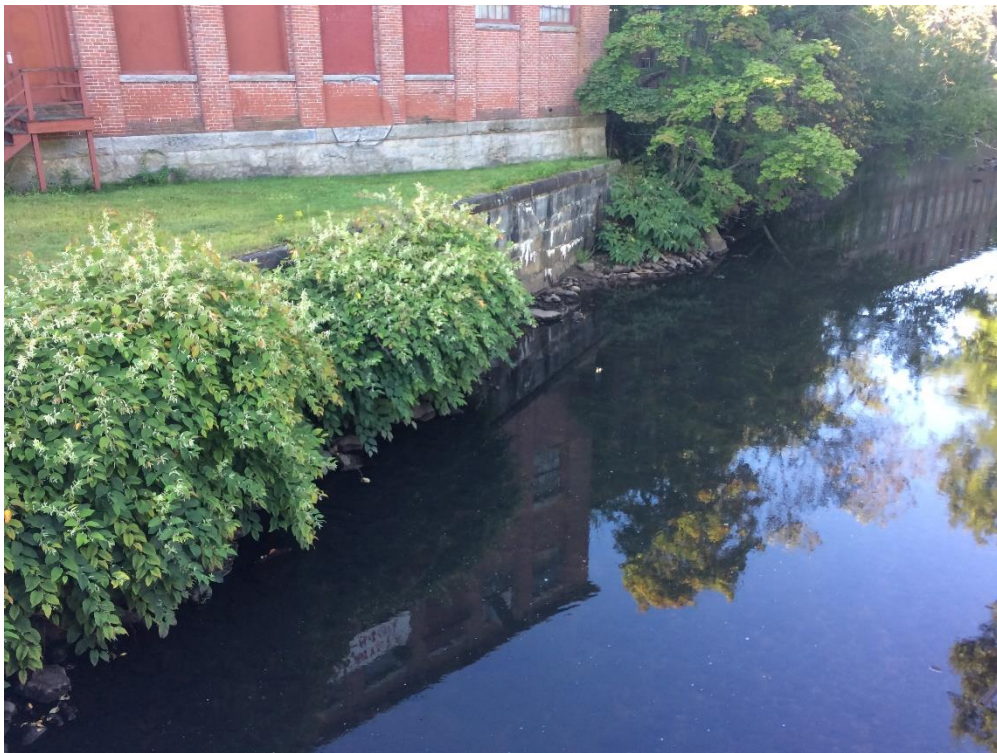
Photograph 8: Vegetation and floodwall upstream of Oak Hill Road.

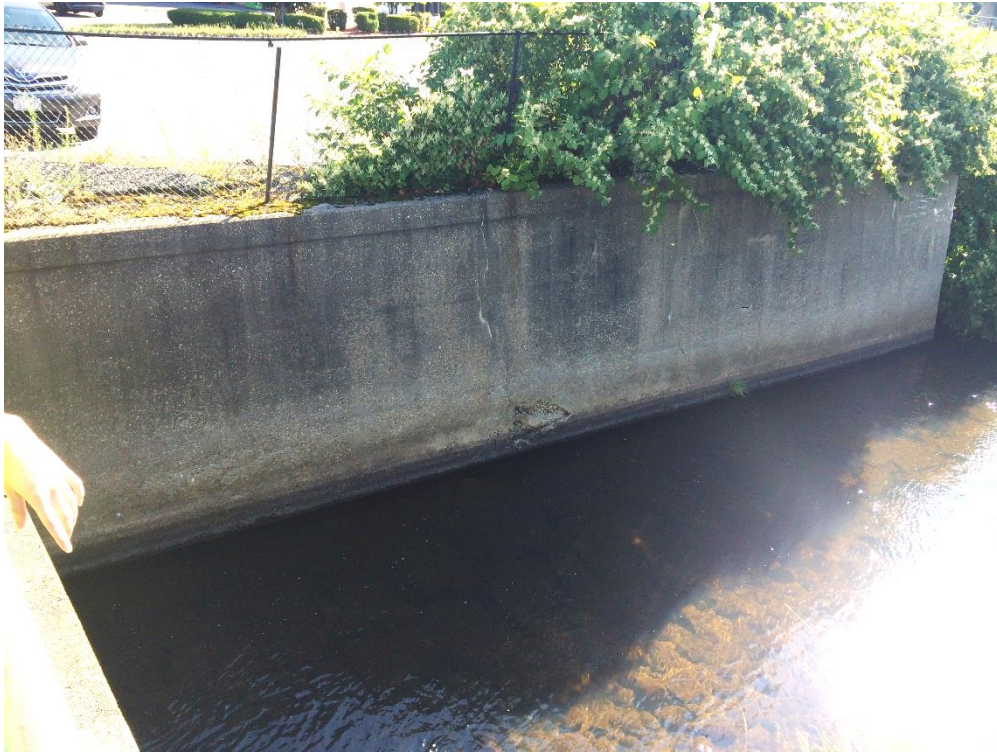
Photograph 9: Cracks and deterioration of the floodwall downstream of Commercial Street.
